Report No. UT-02.07

4th South Street Viaduct Five Year Condition Inspection and Evaluation

**CH2M Hill
4001 South 700 East, Suite 850
Salt Lake City, Utah 84107**

March 2002

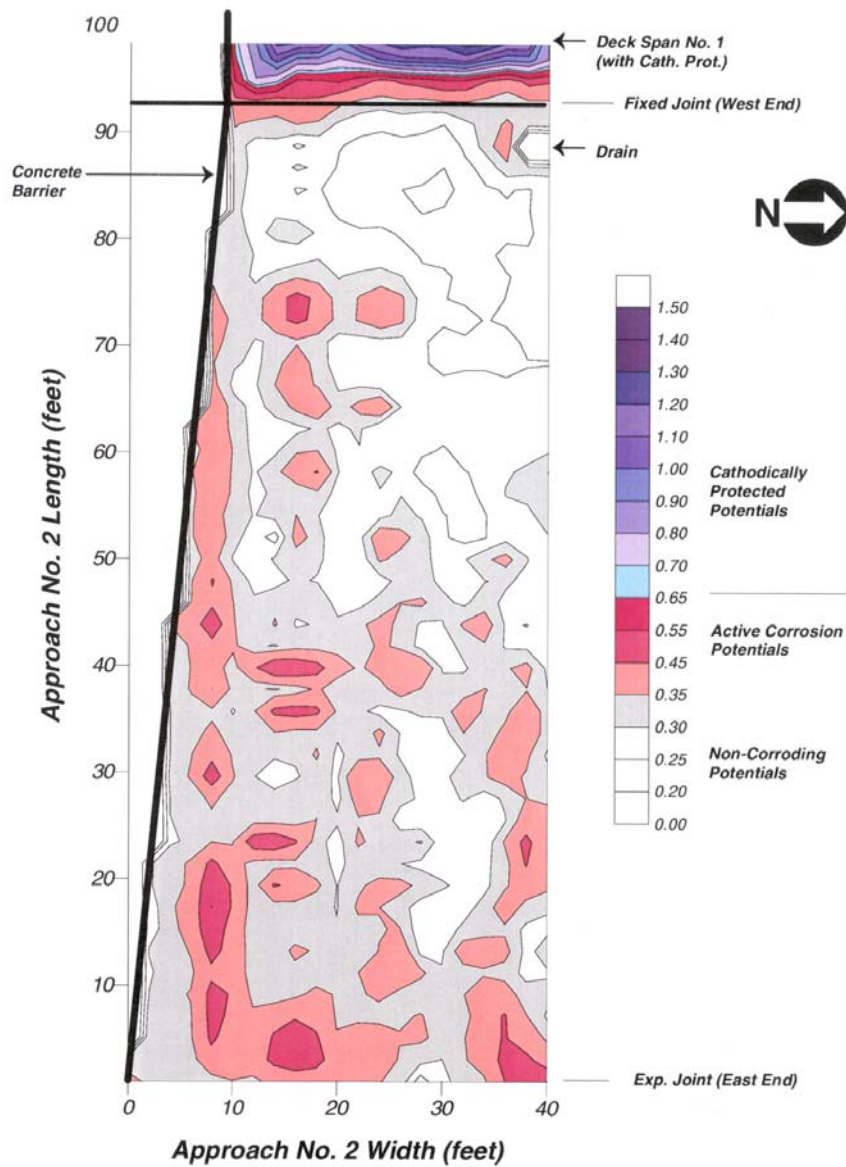
FIGURE 1

Potential surveys were conducted on Approach Nos. 2 and 3 to determine the magnitude and extent of corrosion activity on the steel reinforcement. Figure Nos. 1 and 2 show the results of the potential tests in an equi-potential contour map of each approach. The location and approximate size of delaminations detected on Approach No.3 are shown on Figure 2. Mapping of delaminations on Approach No.2 was not completed because of some uncertainty in establishing the limits of the delaminations.

Active corrosion on steel reinforcement is indicated when the potential is between -0.35 and -0.65 volts to a copper sulfate reference electrode. The more negative the reinforcement potential the greater the magnitude of corrosion and greater the risk that the concrete will become delaminated. Dark red colors show areas of the most active corrosion.

Areas in blue on Figure No. 1, show cathodically protected areas on a portion of Deck No. 1. The red areas adjacent to blue areas are not an indication of active corrosion. Cathodic protection causes the reinforcement to become more negative in potential with increasing current density collecting on the reinforcement. Cathodic protection current attenuates (decreases in density) rapidly with increasing distance from the anode mesh. This results in a similar attenuation of the electrical potential from protected to corroding (unprotected) potentials on the reinforcement. The red areas adjacent to the blue areas indicate that the reinforcement is receiving some cathodic protection current, but of insufficient magnitude for adequate corrosion protection.

Potential Survey
4th South Street Viaduct

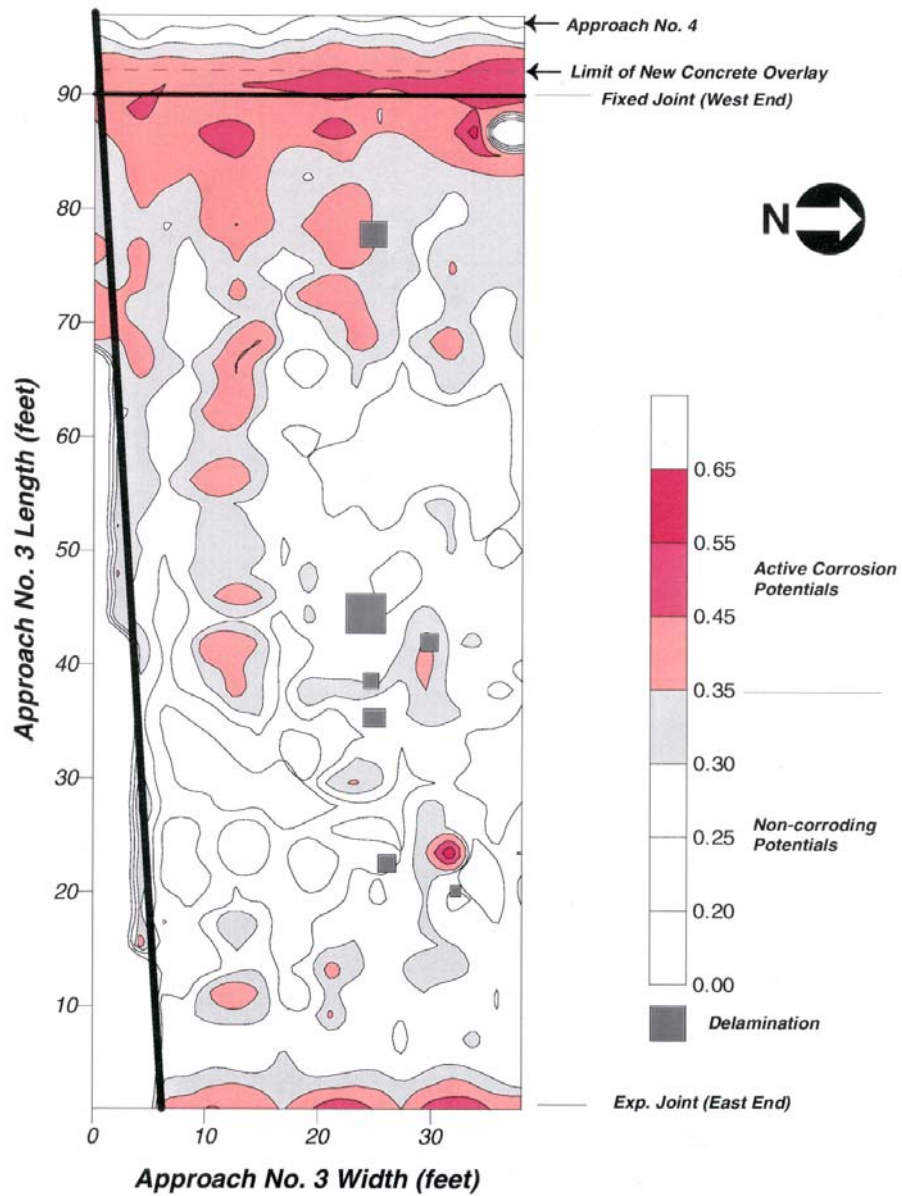
FIGURE 2

Potential Survey
4th South Street Viaduct

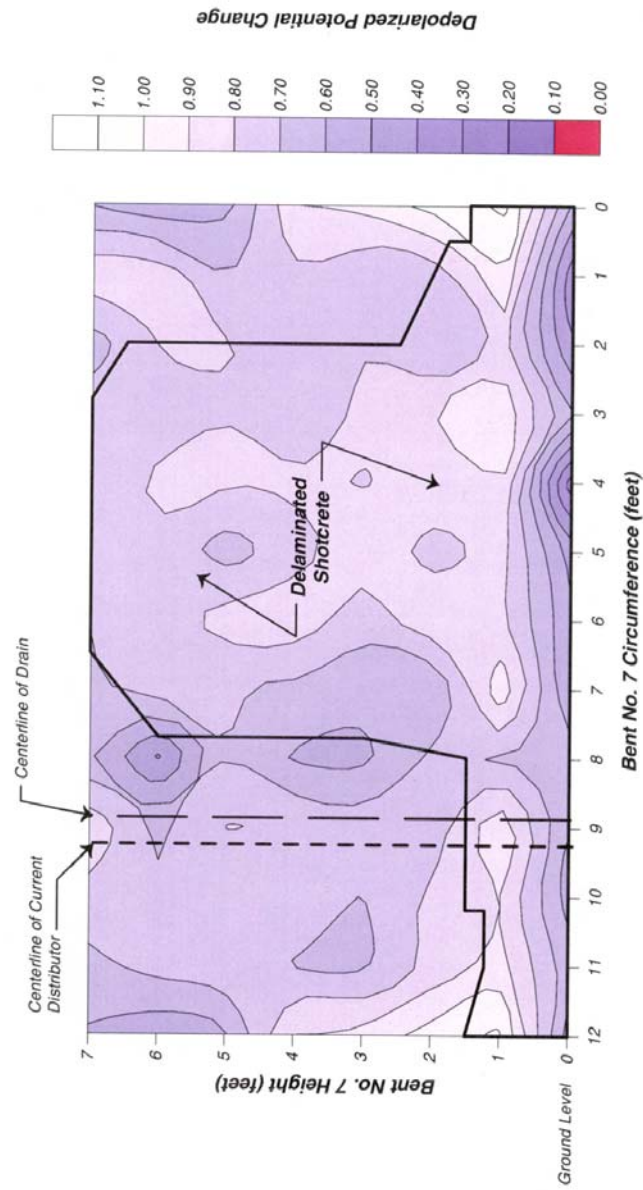
Figures Nos. 3 and 4 shows an equi-potential contour map of the depolarized potential changes that occurred on Bents Nos. 7 and 9 respectively. A depolarized potential change of -100 millivolts or more indicates adequate corrosion protection was achieved. Both of the bent columns were adequately protected even under the disbonded shotcrete. Delamination locations were mapped and shown on the figures to indicate their location and size with respect to the depolarized potential values.

FIGURE 3
Bent No. 7
North Column Depolarized Potential Survey
4th South Street Viaduct

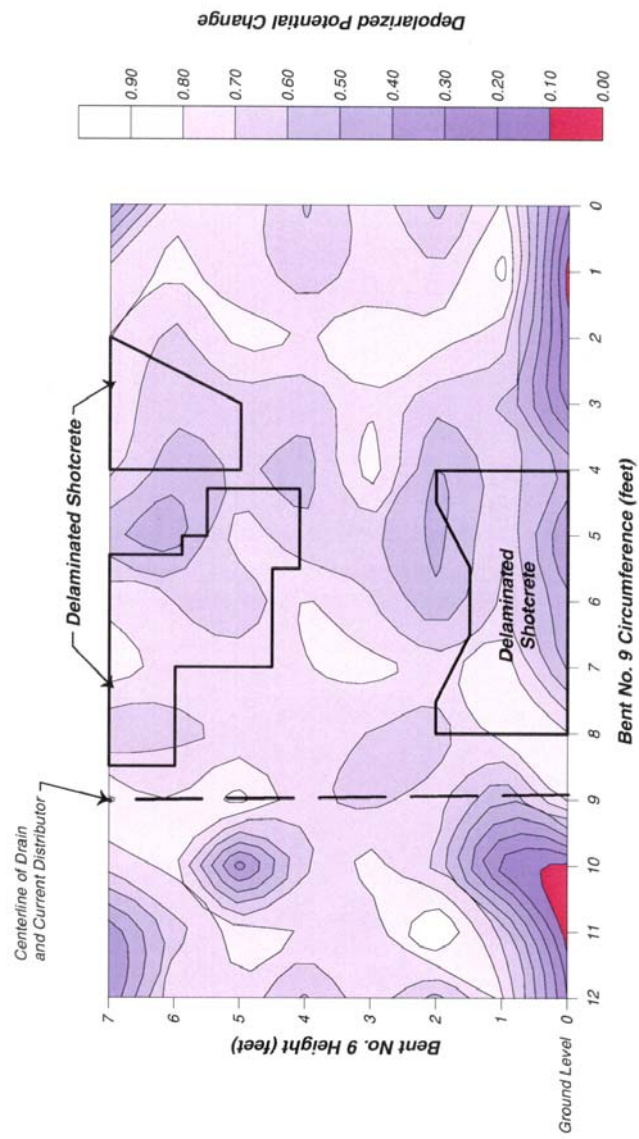
FIGURE 4

The two red locations on Figure No.4 (Bent No.9) indicated areas where the depolarized potential change was less than -100 millivolts. In both locations the poorly protected areas were located outside the delaminated areas and were at ground level. Because these areas showed some polarization, corrosion rate of the reinforcement has been slowed significantly but may not be fully mitigated.

Bent No. 9
North Column Depolarized Potential Survey
4th South Street Viaduct

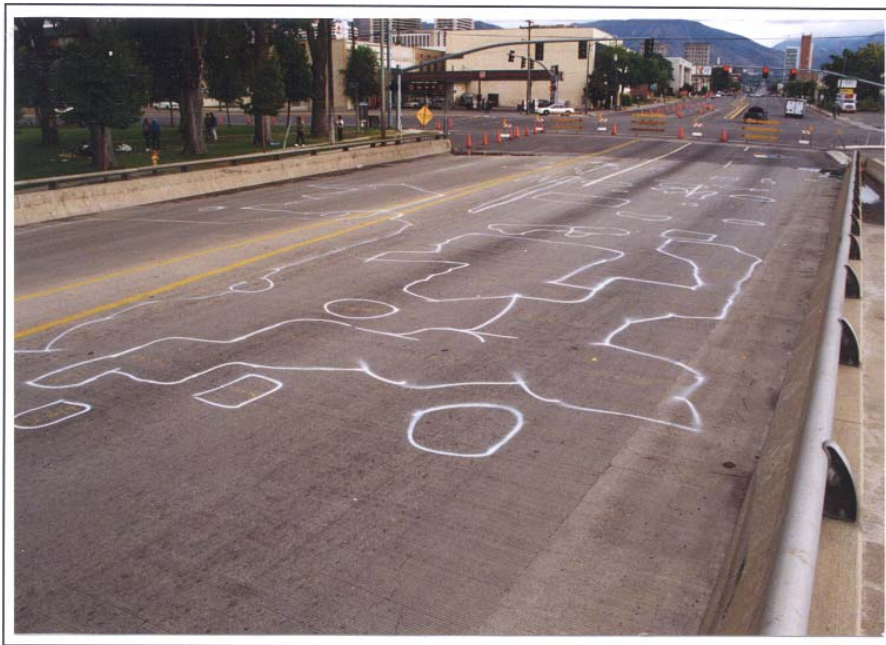
A delamination survey of Approach Span Nos. 1 and 4 indicated over 50 percent of the slabs were delaminated. The riding surface is still in reasonable condition, but is subject to extensive cracking and delamination. Although investigation into the cause of the delamination was not conducted during this inspection, it is suspected that continued corrosion of the reinforcement is causing the delaminations. This conclusion is based on the extent of corrosion activity observed on the adjacent approach spans. Delamination of the LMC overlay may also be a contributing factor to the magnitude of delaminations detected.

Photo No. 1 Approach No.1 with latex modified concrete overlay. Overlay is in fair condition with extensive cracking and approximately 50 percent delaminations as indicated by the white markings.

- Approach Nos. 1 and 4 can continue to be utilized in their present condition for a limited period of time, although budgeting for the future removal and replacement of the slabs should be considered.

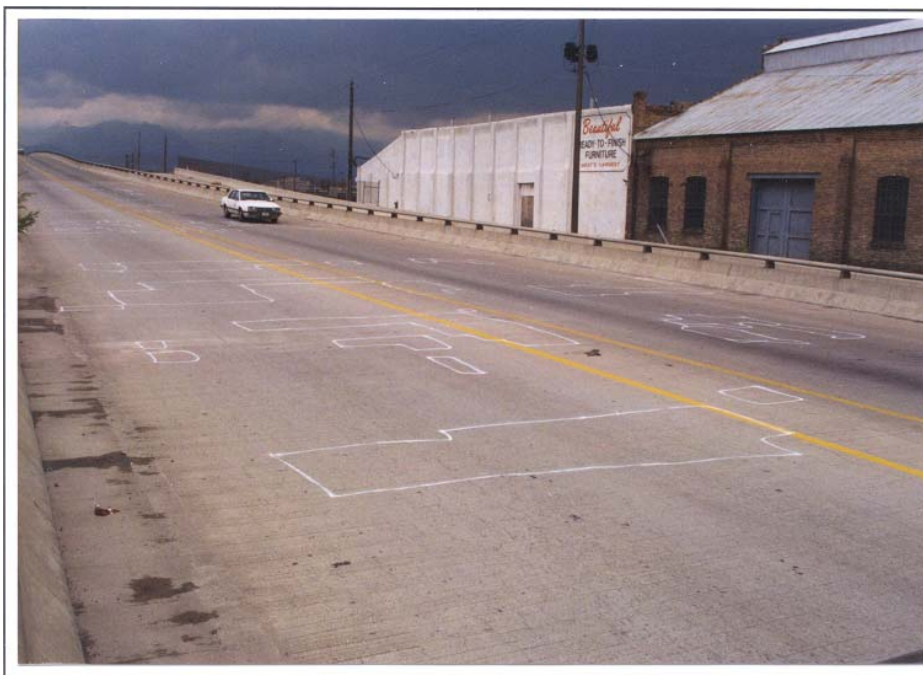
Photo No. 2 Approach No. 4 looking east, white markings indicate delaminated areas detected with a chain drag survey.

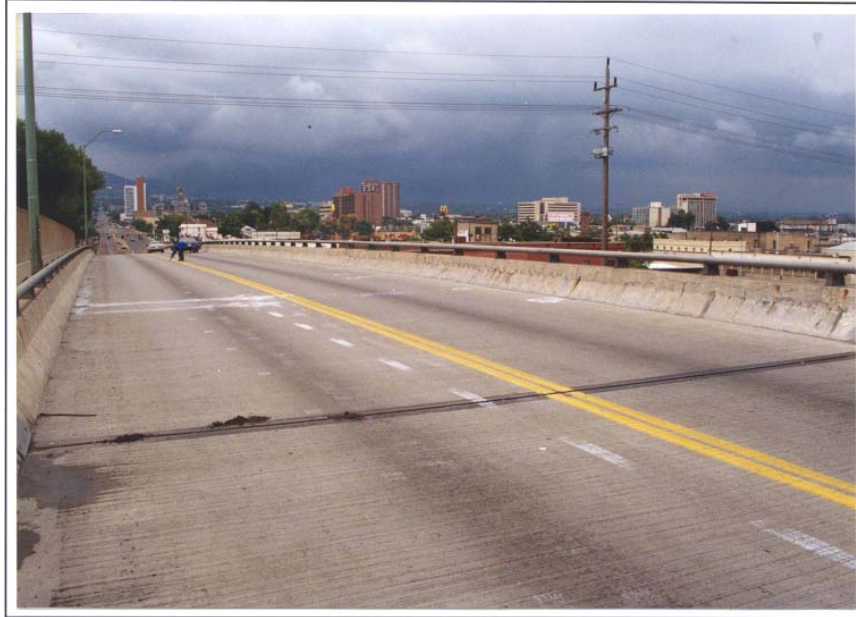
All of the delaminations located on cathodically protected decks were on the steel girder decks, with 95 percent of the delaminations located on Deck Nos. 4 and 5. A small, 1 square foot, delamination was found on Deck No. 12, but it was very tight and difficult to determine if it was actually delaminated. No delaminations were found on Deck No.11.

Two concrete cores were removed from Deck No.5, one in a delaminated area and the other in a sound area. The delaminated core indicated that the delamination was near the steel reinforcement. Closer inspection of the delaminated surface on the core indicated the presence of cement paste over the delaminated surface. This paste condition was similar to that which occurred during the hydro-scarification or demolition work. Presence of a similar cementitious paste was not observed on the delaminated concrete cores taken from Approach No.2. It is very possible that the delaminations on Deck Nos. 4 and 5 are previous delaminations that had not been removed and repaired during the 1988 bridge rehabilitation work. Photographs Nos. 12, 13 and 14 in the Appendix show the cores removed from Deck No.5.

Decks No.4 and 5 were among the last decks to have delaminations removed and patched during the 1988 rehabilitation work. Because delamination quantities were exceeding the contract quantities, there was an increasing desire to minimize the quantity of delaminations removed and repaired to limit the budget overrun. In addition, the steel girder decks had an exceedingly high quantity of delaminations in comparison to concrete girder decks.

Photo No. 3 Cathodically protected Deck No.5, delaminations indicated by white marks. The two white spots on the deck are concrete core locations.

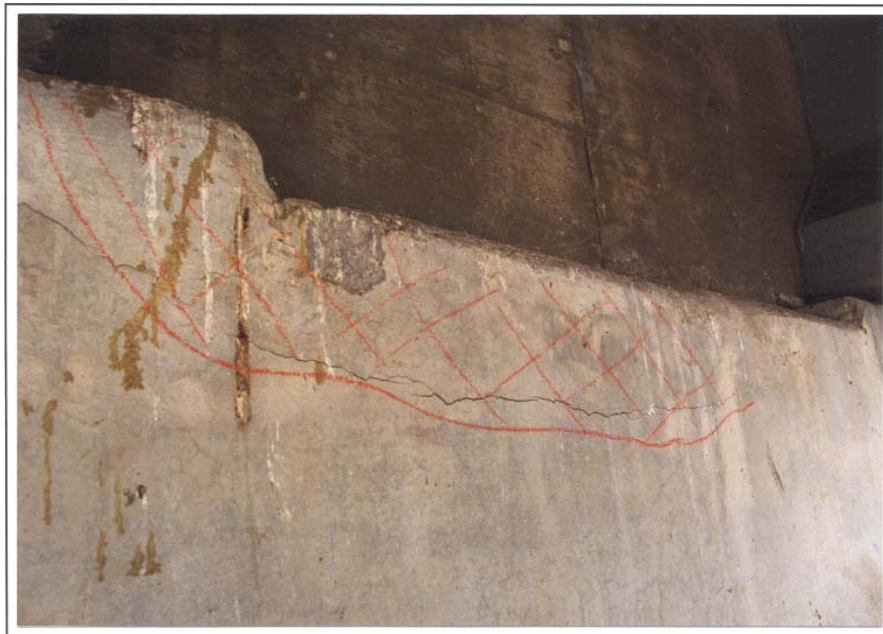
Photo No. 4 Bent No.7 cap on east side. Red marking indicates a delaminated area. Note the crack across the delamination.

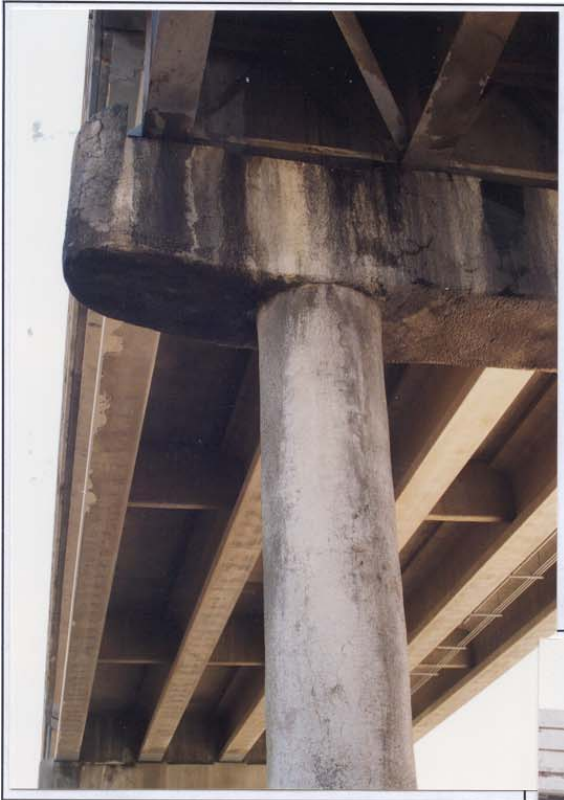
Photo No. 5

Other problems observed with the shotcrete is the breakdown of the shotcrete cementitious matrix in the bent caps where water from the bridge deck runs onto the cap. This was observed at several bents and all were located at expansion joints in the bridge deck. Why the cementitious matrix of the shotcrete has degraded is not known. Petrographic testing was not feasible on the degraded shotcrete samples collected.

Bent No. 10 (looking east) showing water damage along the west side of the cap and breakdown of cement matrix on end of cap.

- Repair the shotcrete on the bents which has been deteriorated from water runoff. Removal and replacement of delaminated shotcrete is not required at this time.

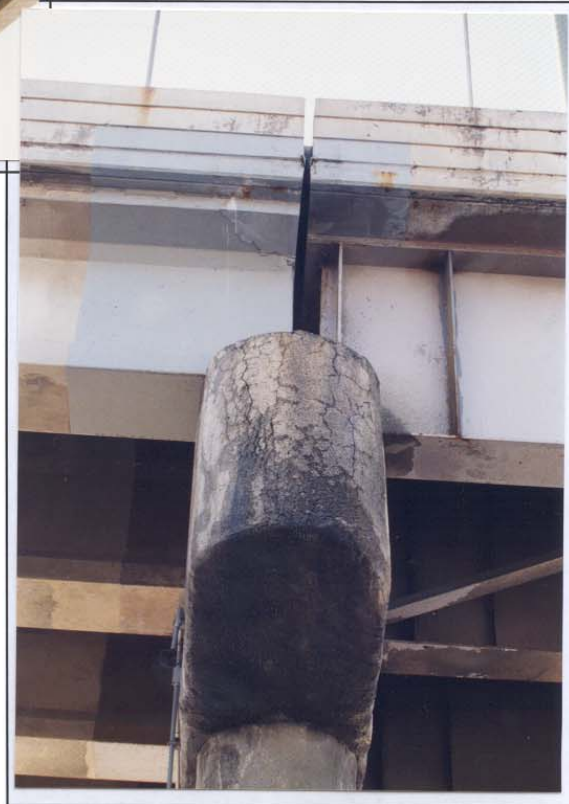
Photo No. 6

End view of Bent No. 10 cap showing the severe cracking and delamination of the shotcrete from water runoff. Breakdown of cement matrix on the top of the cap not visible in photo.

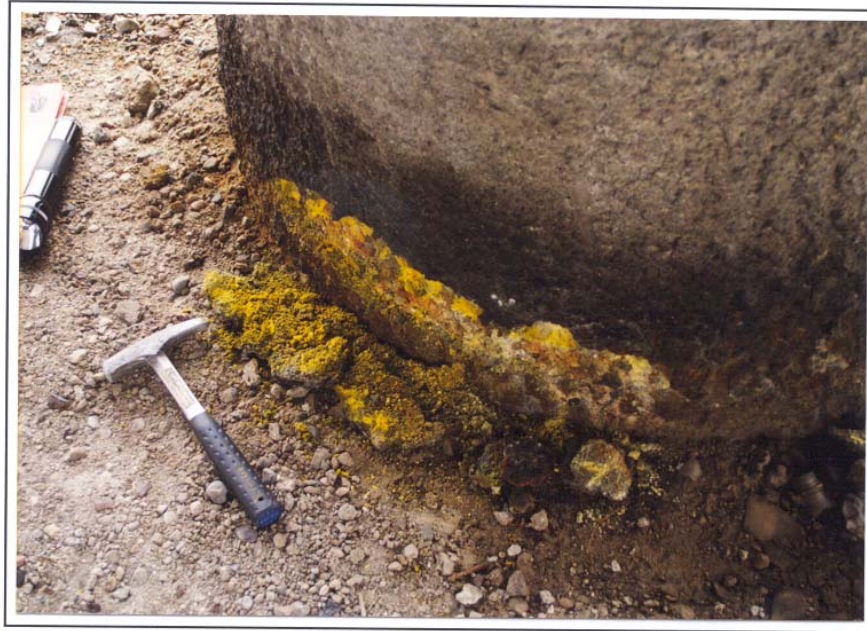
Photo No. 7 Chemical attack of shotcrete on the south side, bottom of the column. Shotcrete is soft and easily removed. Yellow crystals are growing between the shotcrete and concrete substrate.

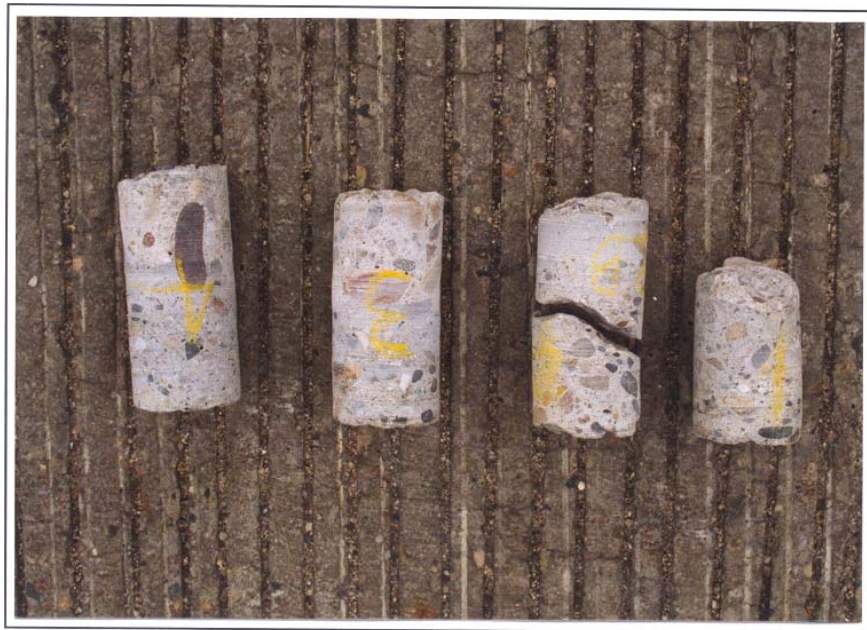
Photo No. 8 Concrete Cores No.1 and No.2 taken from Approach No.2 and Core No.3 and No.4 taken from Deck No.5.

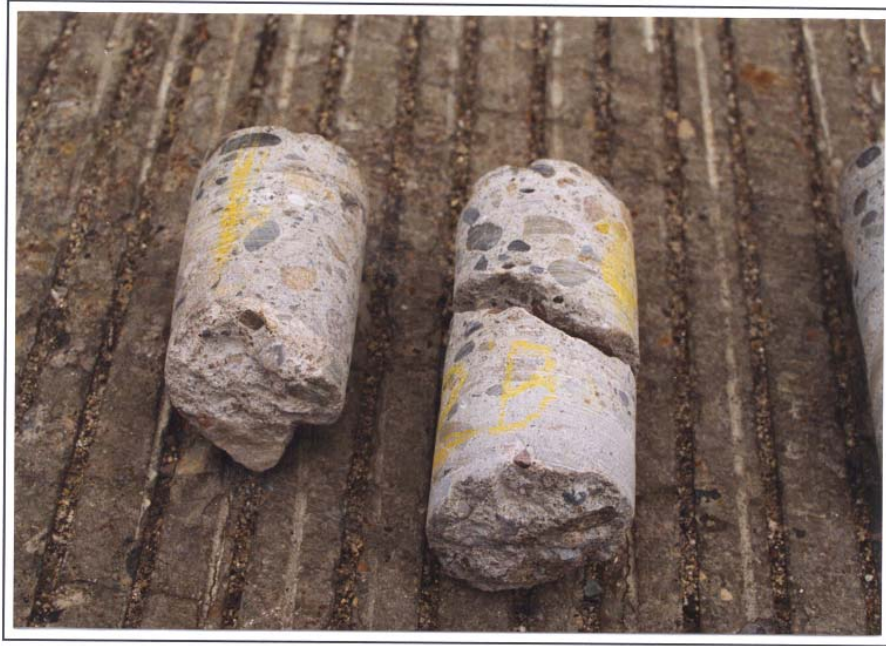
Concrete Core No.2 (Photo No.9) had two delaminations, one within the low slump concrete overlay and a deeper delamination within the original concrete at the bottom of the core. No conclusion is available as to the cause of the overlay fracture.

Photo No. 9 Side view of cores from Approach No.2. Note the double delamination in Core No.2 (right).

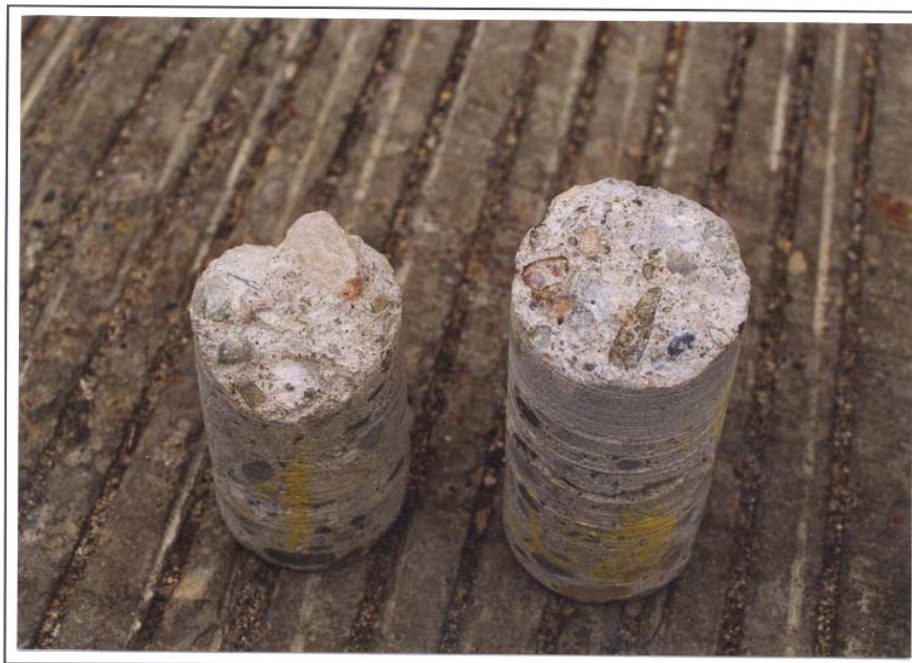
Photo No.10 End view of the core bottoms, core on right has a double delamination. Photo shows the second (deepest) delamination surface.

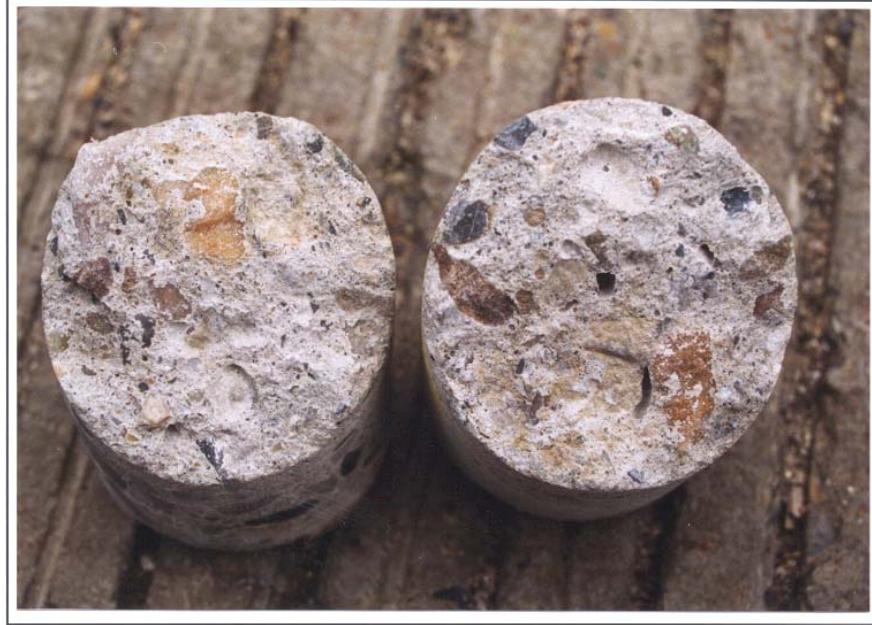
Photo No.11 Close-up of first (upper) delamination in the low slump overlay of Core No.2. The left half is the top portion of the core and the right half is the lower portion.

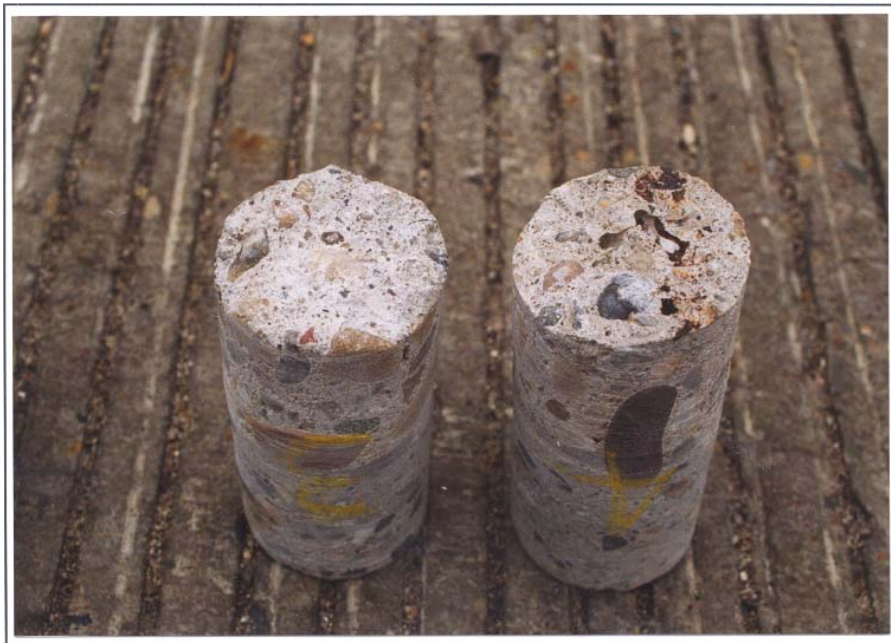
Photo No.12 End view of the Deck No.5 cores. Core No.3 is located on the left and Core No.4 is on the right.

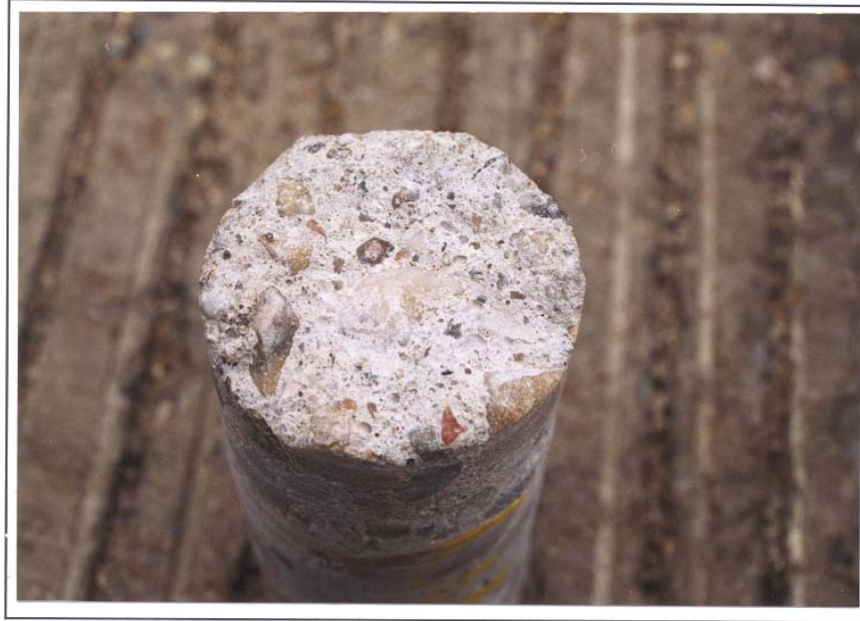
Photo No.13 End of Core No.3 (delaminated core). Cement paste on the fracture surface indicates fracture may be from an existing delamination that was not repaired during rehabilitation

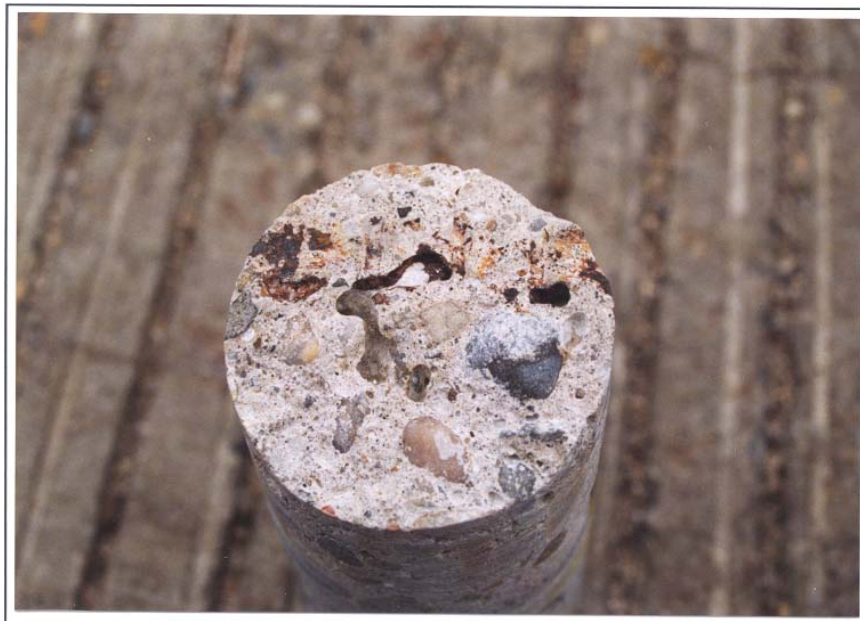
Photo No.14 End of Core No.4 from a non-delaminated area on Deck No.5. Reinforcement corrosion products on core are from corrosion activity prior to the application of cathodic protection. Cathodic protection will not remove existing corrosion products.
